WEC File No. 044829.00

February 22, 2021

Subject: Ice Damming Investigation
Larch Hills Nordic Centre,
Salmon Arm, B.C.

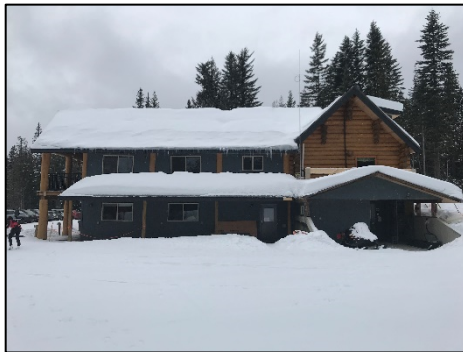
Since completion of the addition, excessive ice damming has been reported on all elevations of the building, including the new shed dormer area.

Photo #1: East Elevation

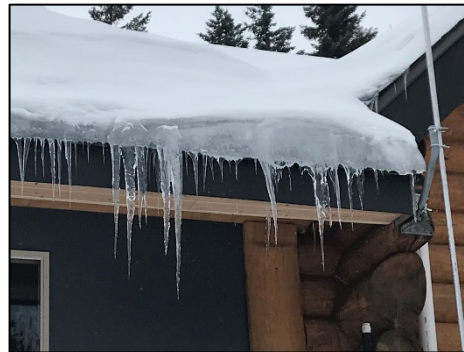
Photo #2: Ice Damming

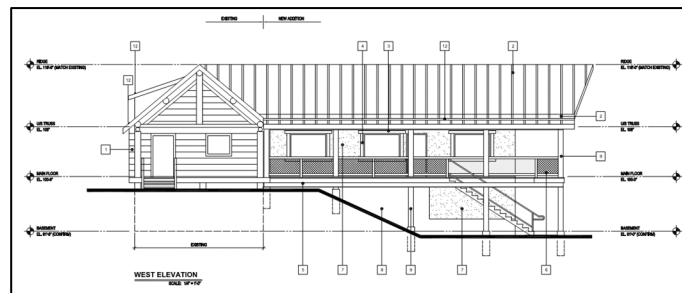
The Larch Hills Nordic Centre is comprised of an original log chalet (constructed circa 1980s) with gabled roof and mezzanine. An addition was added to the building in 2016. Included in the addition was the installation of a shed dormer on the original building (see Sketch #1). The design of the addition was completed by New Town Services of Kelowna, B.C. Construction drawings were provided for our review.

Sketch #1: West elevation (construction drawings)

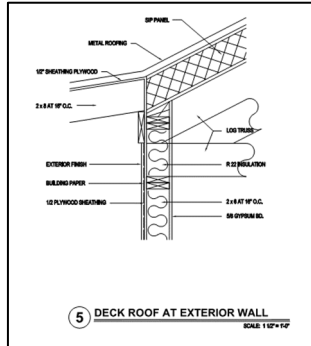
Examination of the construction drawings found the roofing system was not constructed as designed. The proposed structural insulated panel system (SIPS) slated for the new roof portion had not been installed.

Sketch #2: Proposed roof design

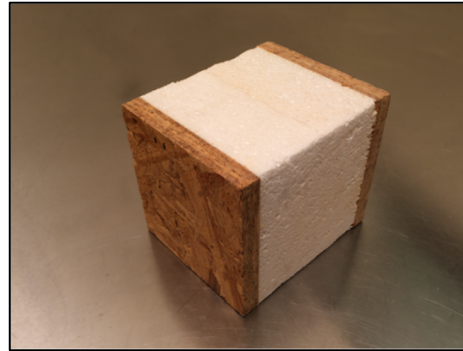
Photo #3: Common SIPS panel design

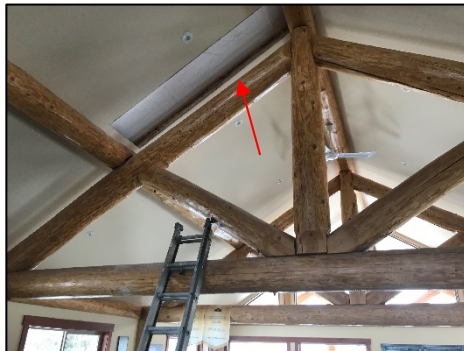
Instead the roof structure appears to be common 305 mm (12") roof I-joists (TJIs) with expanded polystyrene block insulation (EPS) inserted between the joists. The insulation is held in place with wood blocking.

Photo #4: Open ceiling drywall

It should be noted that, in all new construction areas that were examined, no polyethylene vapour retarder was found between the insulation and interior ceiling drywall.

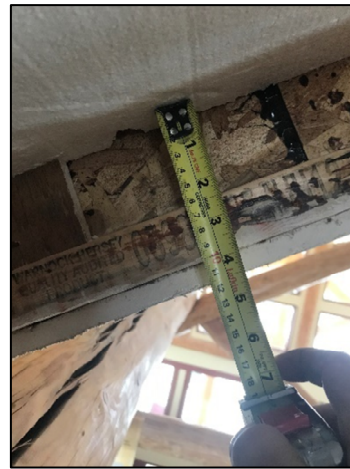
Photo #5: Insulation recessed between joists

The use of EPS insulation in the addition and dormer sections is acceptable from an insulation perspective however, little to no effort appears to have been made to make the underside surface of the EPS airtight at joints and connections. Further, given the position of the log framing, there would be certain areas where creating an effective airtight connection would be exceedingly difficult.

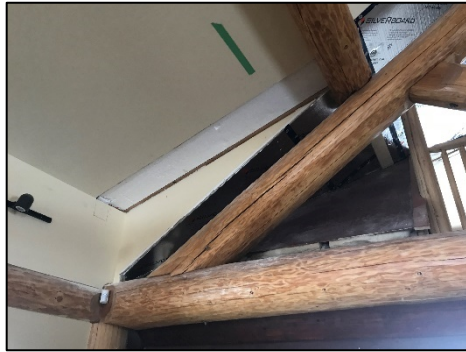
On the west portion of the new roof, where the roof angle changes and extends over the exterior walkway, it appears 2x8 dimensional lumber joists were used instead of TJIs. The space between the dimensional lumber joists were completely filled with expanded polystyrene.

Photo #6: Framing and insulation at roof slope transition

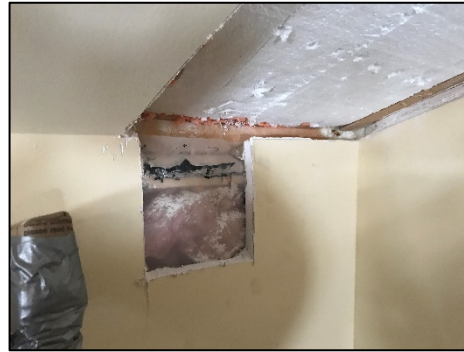
Photo #7: Ceiling to wall junction

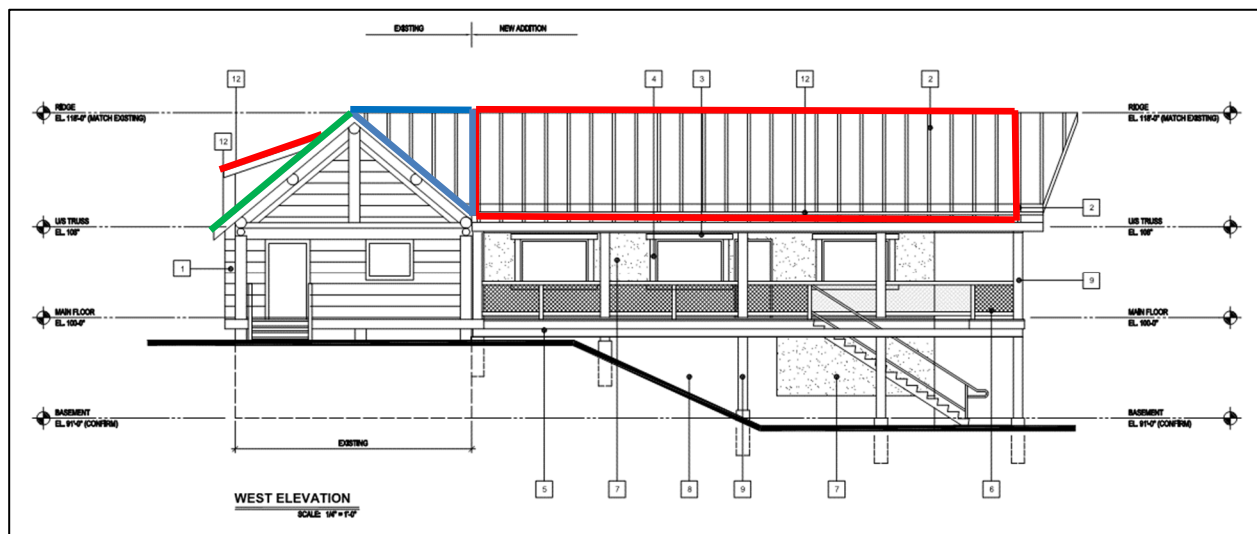
In the existing roof area, the remaining roof structure along the south slope appears to have been insulated with $\frac{1}{2}$ lb/ft³ density, open cell, spray-applied, polyurethane foam, with a 25 mm thick layer of foil-faced, polyurethane insulation installed inboard, over the new roof framing. Please note that this foil-faced insulation was not used behind the tongue and groove (T&G) ceiling finish.

At the time of the site review, the ceiling drywall where the new roof joins the existing roof, had not been installed. The north portion of the existing roof appears unmodified with fiberglass batt insulation and polyethylene vapour retarder. The shed dormer is constructed in a similar fashion to the roof in the new area although a carbon-infused expanded polystyrene has been used which has a slightly higher thermal resistance (R-value) per inch.

Sketch #3: Insulation in various roof areas

- EPS Insulation between roof joists (addition)
- Original Batt Insulation with Poly Vapour Retarder
- Open Cell Spray Foam and Foil-Faced Polyurethane Board

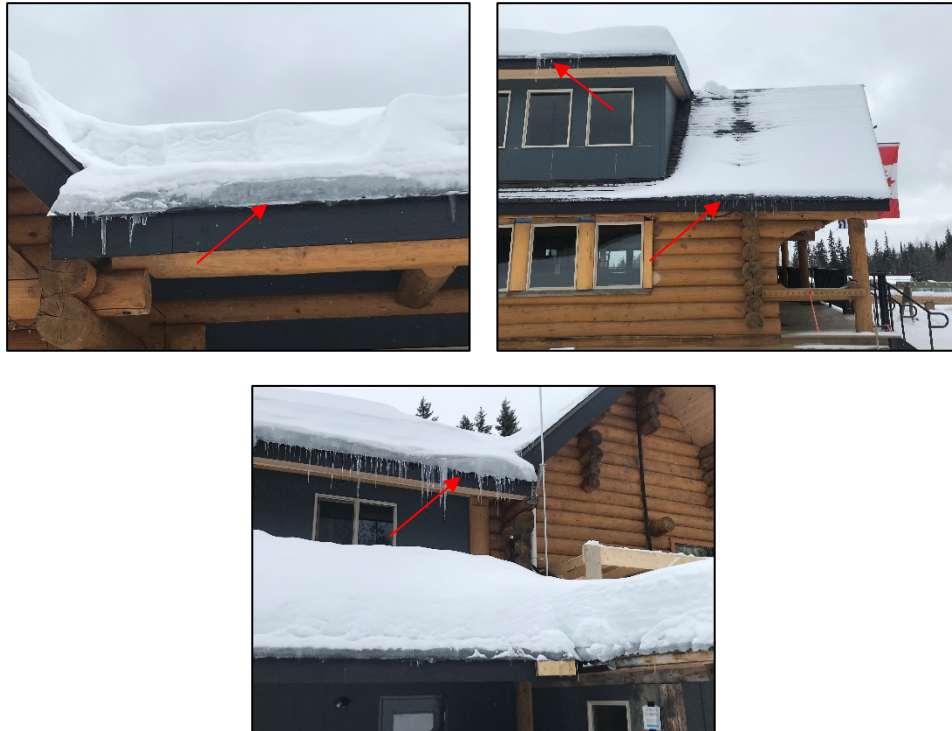
The Ice damming observed during the site visit occurred on all elevations, except the south as no eave exists on that elevation. The amount of ice damming varied depending on location.

Photos #8, #9, #10: Examples of ice damming

The current level ice damming on the building is caused by non-continuous thermal insulation and ineffective control of air leakage within the roofing system.

This option requires the removal of the existing drywall, interior finishes, and insulation materials to expose the roof structure and underside of the roof deck. The underside of the roof deck would then be sprayed with 150 mm (5") of 1.8 – 2.0 PCF density, closed cell, spray-applied polyurethane foam insulation (BASF "Waltite", Icynene "MD-C-200", etc.). The insulation would be applied in maximum 50 mm lifts to ensure any cavities that form in the billowing foam are sealed. The thermal resistance of the roofing system would be approximately R-30. Please note that although spray foam is very effective in creating a tight air seal, vapour seal and thermal blanket, it is unreasonable to assume that all holes will be eliminated. The benefit of spraying to the underside of the roof deck is that, if a small hole (or "inlet") in the foam exists, as there is no ventilation space between the foam and the underside of the roof deck, there is no "outlet" to allow for air to escape. Air flow is therefore significantly restricted if not completely eliminated. Another issue may pertain to the warranty of the shingles installed on the building. A number of shingle manufacturers will not warrant their products in an unvented application as it is believed that without the ventilation space below, excessive solar heat gain would reduce the life span of the shingles. This would have to be confirmed with the manufacturer of the shingles used on the building.

This option is similar to Option #1 in that the roof structure and deck would be exposed and 1.8 – 2.0 PCF density, closed cell, spray-applied polyurethane foam insulation would be used to create the air barrier, vapour seal and thermal blanket. The difference here would be that cardboard baffles would be installed between the roof joists to create a 63 mm (2.5”) ventilation gap between the underside of the roof sheathing and insulation. This would have to be installed in conjunction with ridge and soffit ventilation required by the BC Building Code for a roof of this type. The ventilation area requirement is 1/300th of the insulated roof area relatively evenly split between the soffits and ridge. Therefore, a ventilated soffit and ridge venting would need to be constructed. As the soffit is currently constructed of T&G boards covering the structural elements, this would need to be removed so a vented soffit could be constructed. Further, as it appears there is horizontal blocking between the joists at the building-to-walkway roof transition on the west elevation, this would have to be modified to allow for air flow from the ventilation space through the soffit. At the roof peaks, a continuous ridge vent would need to be constructed as it appears that the roof sheathing was not strapped. Given the heavy winter snowpack, the ridge vent would need to be a raised “dog house” style to ensure the vent is not covered over with snow. As stated above in Option #1, some minor air flow through the spray foam is possible. As this methodology provides an “outlet” through the roof vent space, air leakage may occur. The requirement of the spray foam installer achieving a tight air seal is therefore much more critical. Please note this methodology can be used with simple batt and poly in lieu of spray foam insulation however, achieving a tight air seal is exceedingly difficult and is not recommended.

This option also requires the removal of the existing drywall, interior finishes, and insulation materials to expose the roof structure and underside of the roof deck. The shingles and underlayment would also be removed. A new self-adhered membrane would then be installed over the entire roof. One layer of 75 mm (3”) rigid insulation would be installed over the membrane, held in place with 75 mm (3”) vertical Z-girts. A second layer of 75 mm (3”) insulation would then be applied over top with the Z-girts installed horizontally to reduce thermal bridging. The thermal resistance of the roofing system would be approximately R-30. The assembly would be covered with an underlayment and the roof finished with a sheet metal system. Shingles could be applied, but an additional layer of exterior sheathing would be required over the Z-girts to allow for fastening of the shingles. This method effectively seals the roof and moves the roof joists to within the building envelope.
