Larch Hills Trail Lighting Project - Phases 1-4

Environmental Impact Assessment

Background Report

March 2020

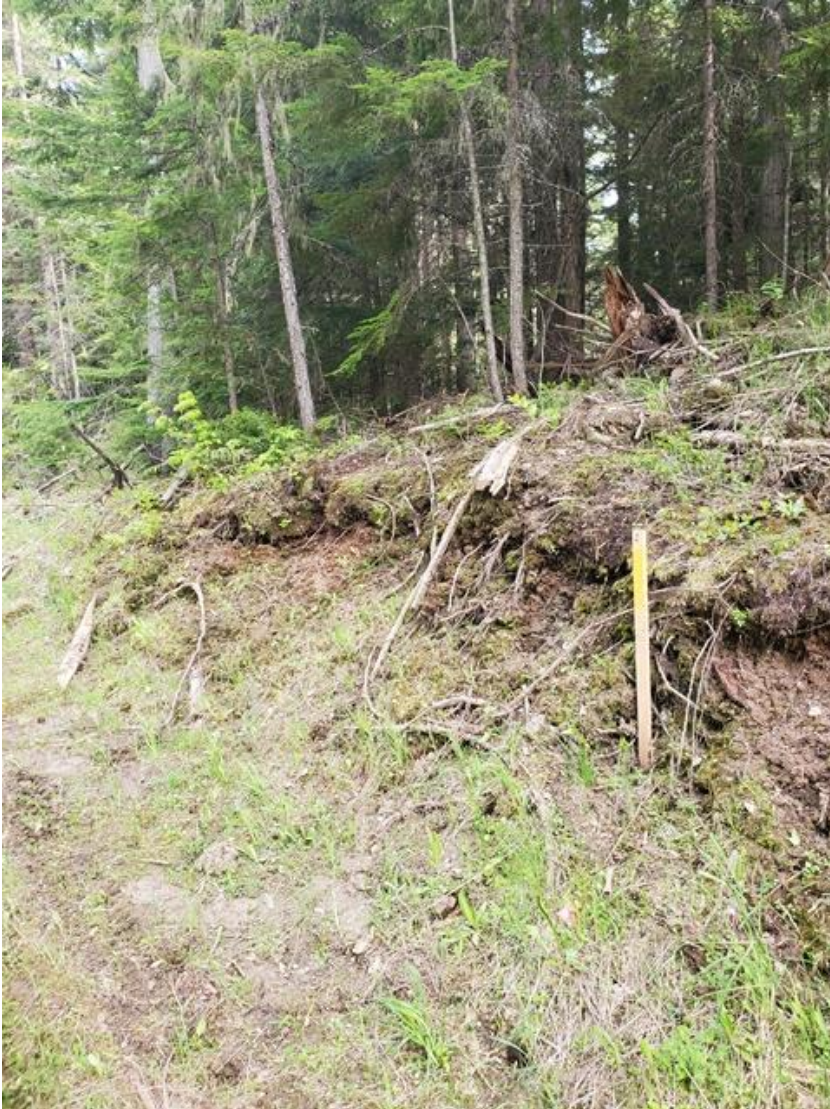
Figure 1. Photo of a staked light post location along Phase 1 of the Larch Hills trail lighting project. Each light post location was visibly assessed for plant species at risk (based on Table 1), signs of wildlife and wildlife habitat features (eg. nests).

We assessed the light post sites for Phase 1 (33 posts) and Phase 2 (38 posts) in early August 2020. No plant species at risk were identified and no signs of wildlife or wildlife habitat features were observed within the impact area of each light post. The area of impact that was visually assessed was approximately 9 m² (3 m x 3m) centered on each staked light post.

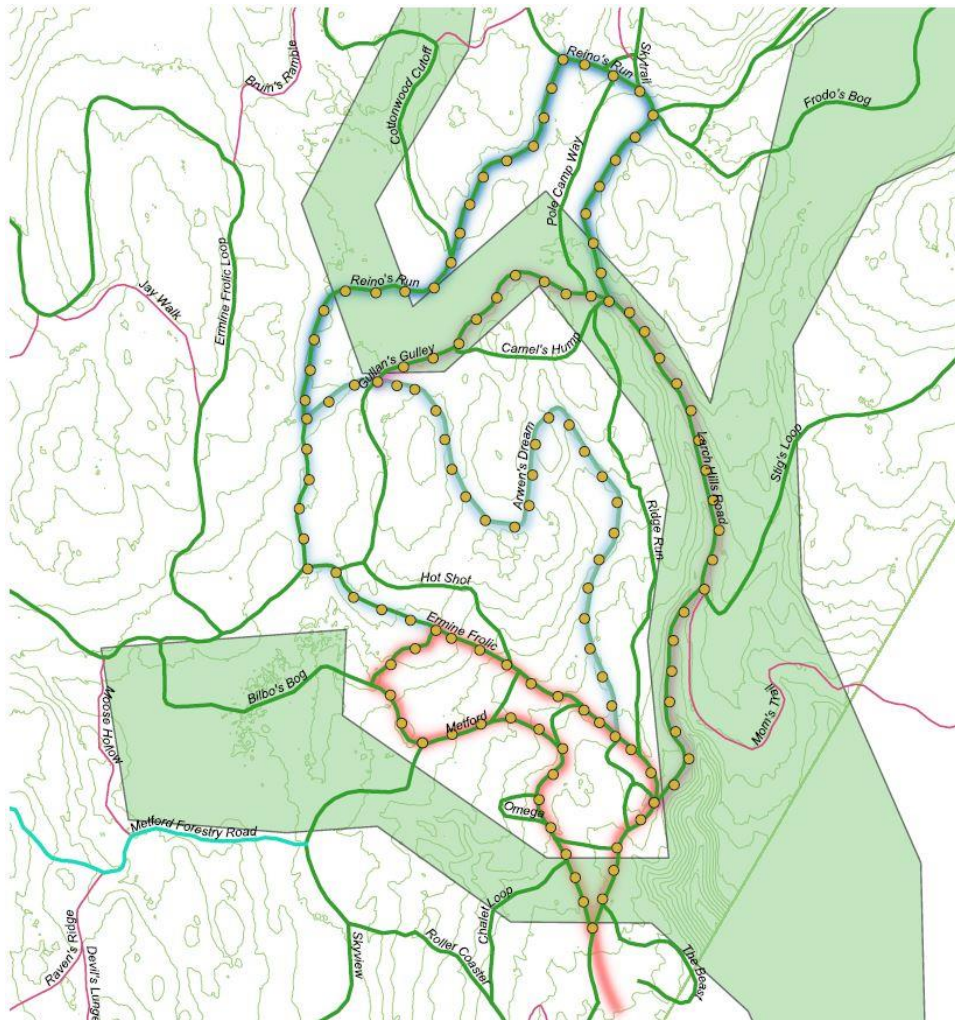
- Light Poles [126]
- Lighting Phases
- Phase 1
- Phase 2
- Phase 3
- Phase 4

Map 1. Larch Hills central ski trails showing the 4 phases of development of lit trail and the location of the Upper Violet Creek Provincial Park.

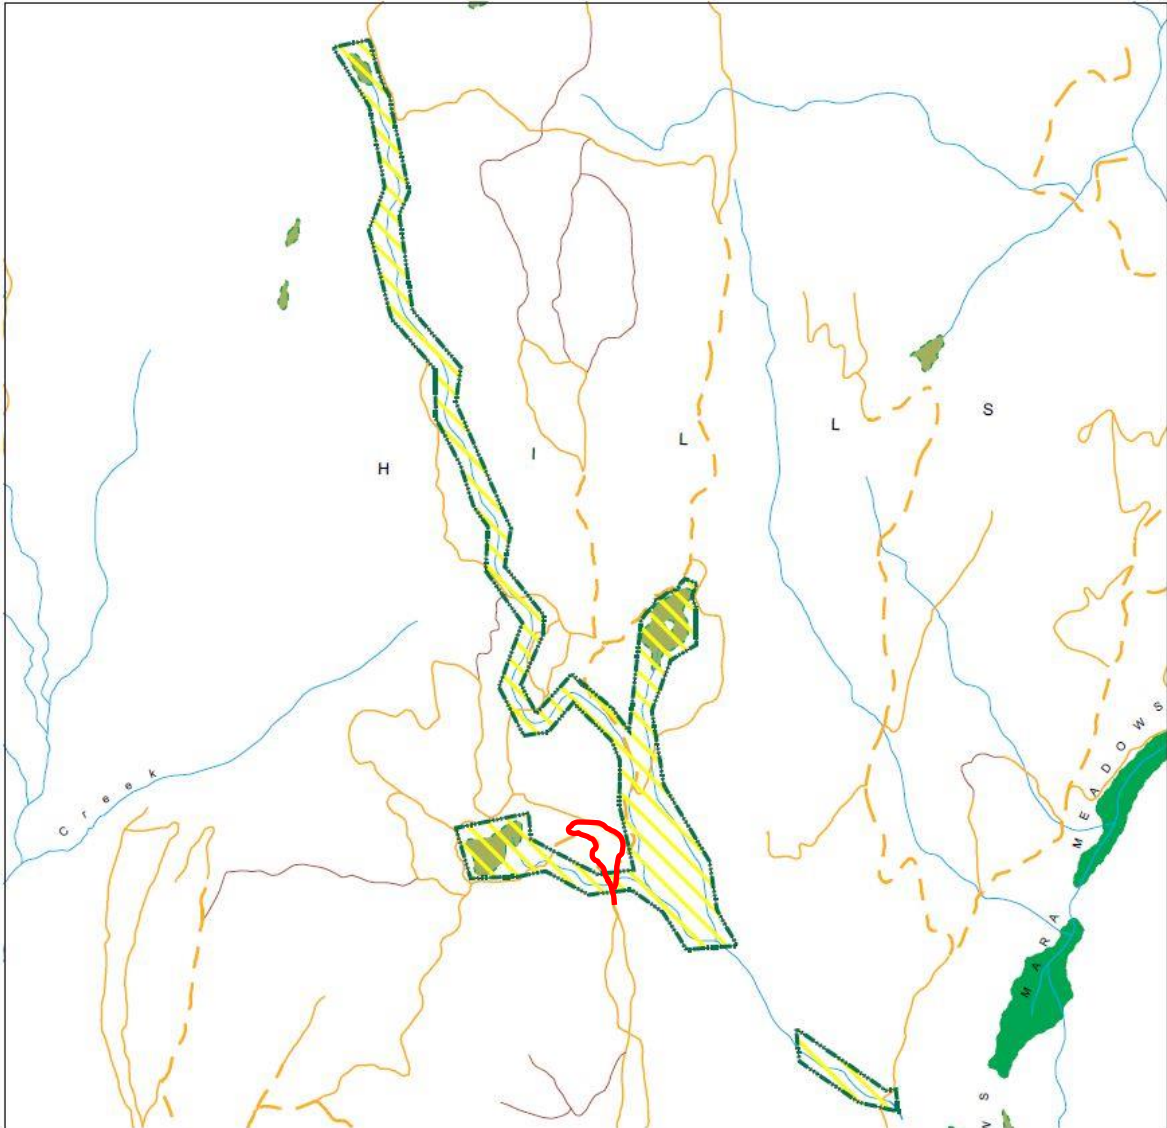
Map 2. The location of Larch Hills Trail Lighting Project Phase 1 (red) as a reference to the location of the Upper Violet Creek Provincial Park (yellow cross-hatch) and the Mara Meadows Ecological Reserve (dark green) downstream of the Park and ski trails.

The Upper Violet Creek Provincial Park was created primarily to protect two major water sources that enter Mara Meadows Ecological Reserve downstream of the ski trails (see Map 2). The Mara Meadows Ecological Reserve is a rare mid-elevation calcareous fen, a unique wetland habitat that supports rare plants and is dependent on the maintenance of the existing quantity and quality of water flowing in from Upper Violet Creek. The secondary role of the Upper Violet Creek Park is to provide for the continued recreational use of the cross country ski trails that cross through the area and are thought to pose little threat to the park values (Upper Violet Creek Provincial Park Purpose Statement and Zoning Plan 2006). The Upper Violet Creek Park boundaries are roughly 50 m parallel on either side of the main Violet Creek stream channel, including the 2 tributaries that are the outlets to boggy wetlands known as Bilbo's bog and Frodo's bog.

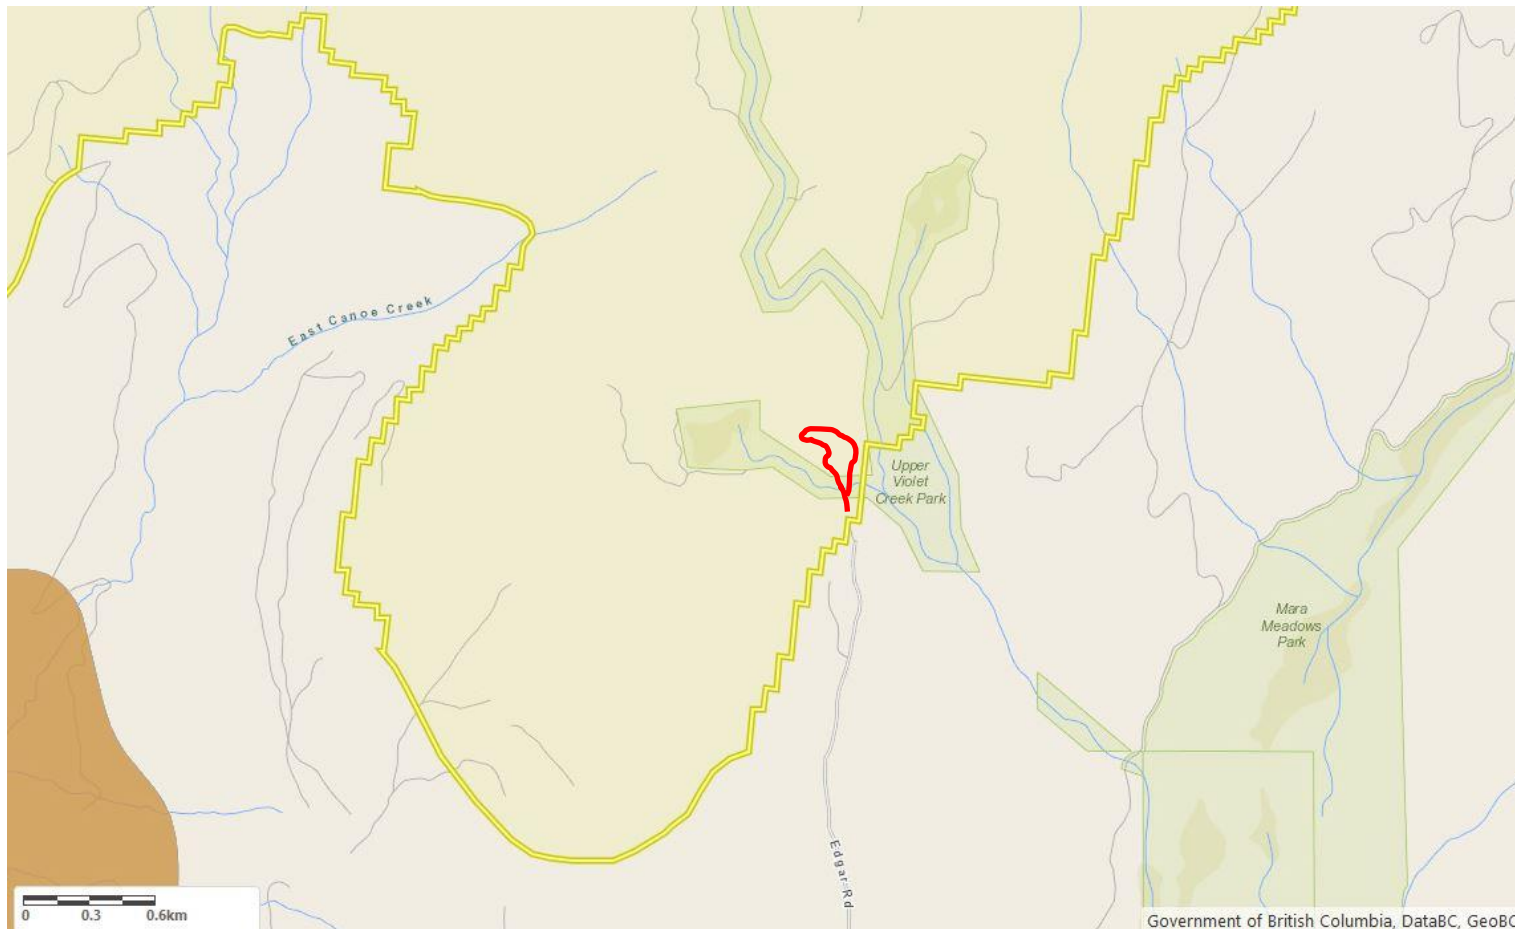
Map 3. The location of the Phase 1 trail section (red) as a reference for the Trail Lighting Project that is entirely within the ICH mw 5 (Interior Cedar Hemlock moist warm Granby) biogeoclimatic subzone variant (yellow), which extends north across the Larch Hills above ~1000 m elevation.

Biophysical land classification in this area includes the Shuswap Highland Ecosection, which is well represented (17%) in the Provincial Parks and Protected Areas system. The Trail Lighting Project trails are also within the ICH mw5 (Interior Cedar-Hemlock Granby moist warm) biogeoclimatic subzone variant. The Natural Disturbance Type here is listed as NDT2 (ecosystems with infrequent stand-initiating events). The ICHmw5 biogeoclimatic subzone variant encompasses a 5800 hectare area above ~1000 m elevation and extends north to Sicamous across the entire larch Hills. All four Phases of the Trail Lighting Project will be between 1000 and 1060 m elevation. The vegetation along the trail corridor is typical of the ICHmw5.

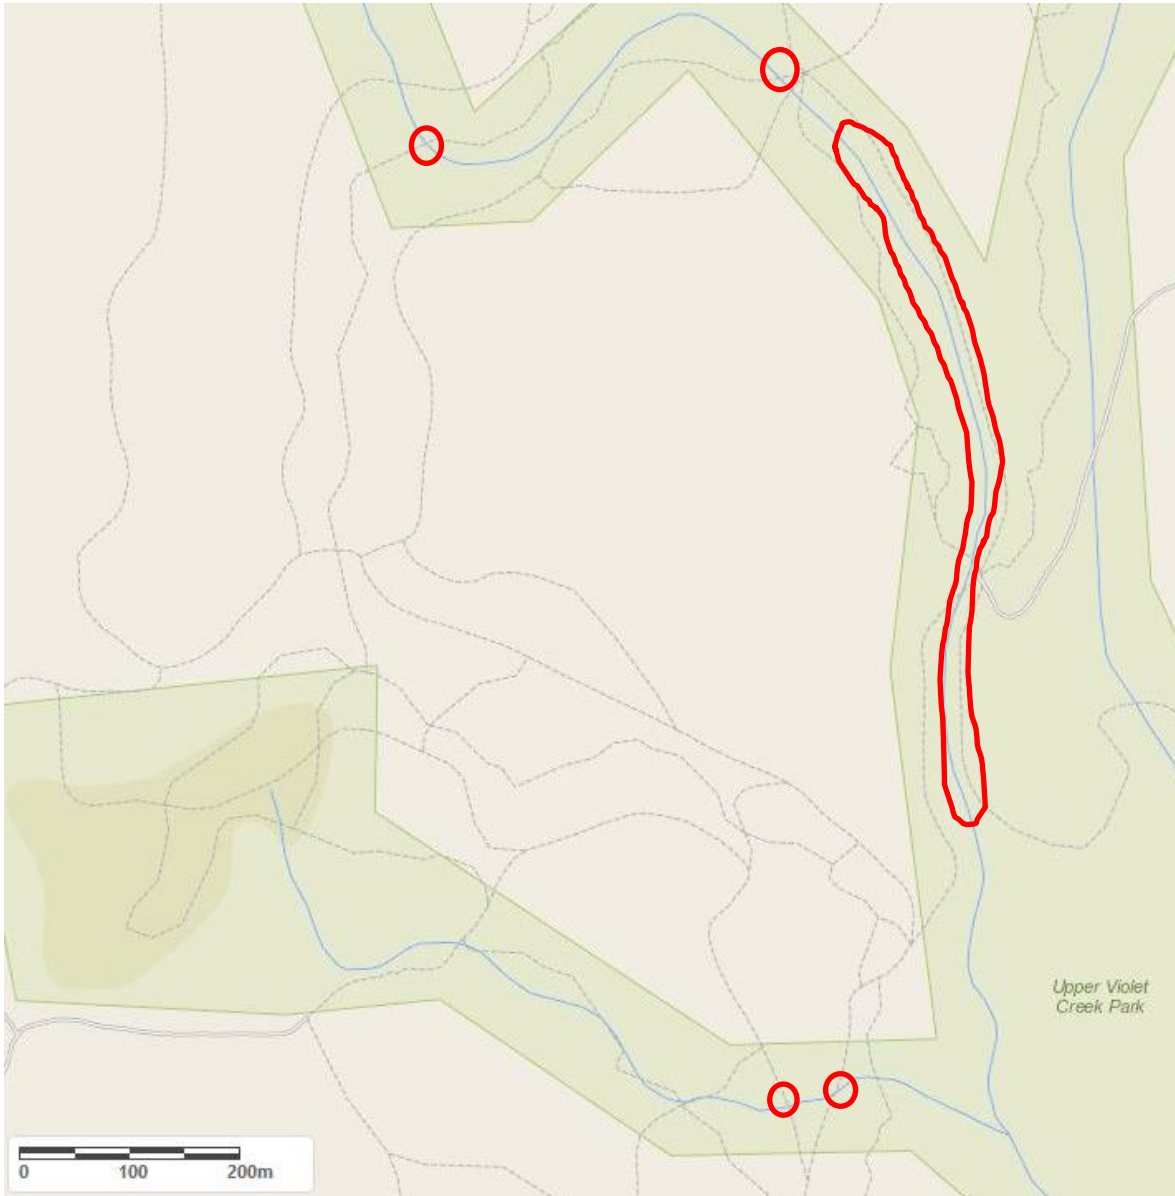
Map 4. This map shows the location of the Upper Violet Creek stream channel and areas where the Larch Hills Trail Lighting Project will cross within close proximity to the stream channel on existing road beds (red circles). Specific riparian tree/vegetation protection as well as sediment and erosion control measures will be required in these areas to avoid negative impacts to sensitive aquatic and riparian habitat values.

Likely the most environmentally sensitive sites within the project area will be where the lit trail crosses or is adjacent to stream channels. The impacts of concern will be directly related to installation of trail light poles and trenching underground wiring. Although trenching and pole installation be within previously disturbed road beds, specific

mitigation measures will be required to protect water quality and sensitive riparian plant and animal habitat when in close proximity to stream channels (i.e., along Larch Hills Road). These mitigation measures will include locating light poles where they will have minimal disturbance/damage to riparian trees and vegetation, as well as controlling the potential for sediment and erosion to occur during construction, resulting in sediment-laden water entering the stream channel. Depending on site specific details, sediment and erosion control measures may include installing silt fences, avoiding excavation or tarping stockpiled soil during heavy rain events, and grass seeding immediately following installation of light poles and trenching within these sensitive areas. Details of this riparian mitigation will be developed during the spring-fall 2020 prior to any excavation work.
