LARCH HILLS NORDIC SOCIETY

Annual General Meeting

LARCH HILLS NORDIC CHALET ROOF INSULATION REPAIRS

Subject: Ice Damming Investigation
Larch Hills Nordic Centre,
Salmon Arm, B.C.

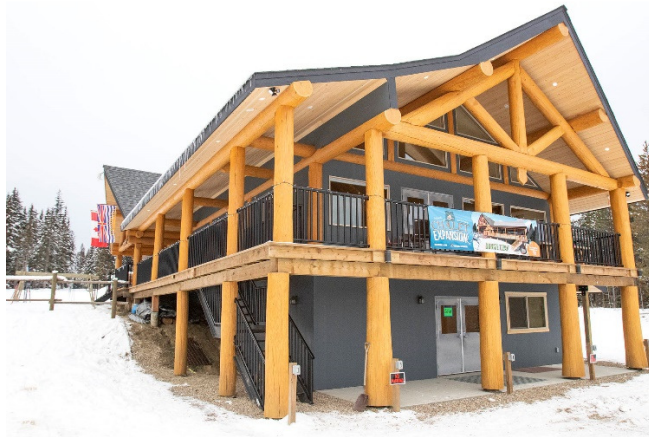
Problems:

- Heat Loss.
- Severe ice damming and heavy icicle formation.
- Melt water backing up and leaking into overhangs and soffits.

Proposed Solution:

The research shows there is an ongoing debate between vented and unvented systems for cathedral ceilings. If only I had a nickel for every opinion I found... Although Williams engineering has had success with both systems, they recommended the **unvented system** for it's simplicity and felt it had less overall risk. The spray foam suppliers that were contacted were also adamant that the unvented system is the preferred method and have sprayed many successful unvented roofs from Revelstoke to Silverstar.

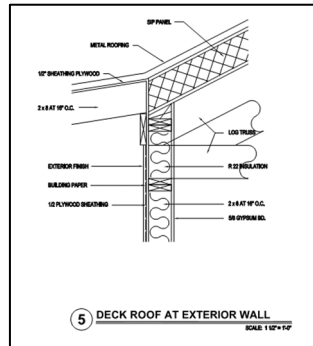
Sketch #2: Proposed roof design

Examination of the construction drawings found the roofing system was not constructed as designed. The proposed structural insulated panel system (SIPS) slated for the new roof portion had not been installed.

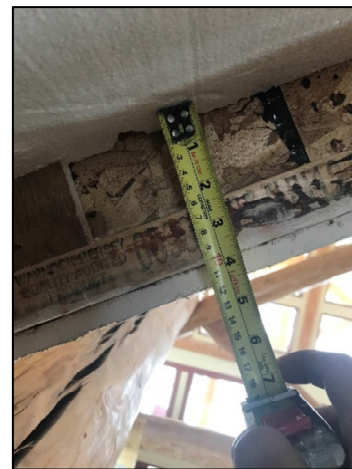
Photo #5: Insulation recessed between joists

Instead the roof structure appears to be common 305 mm (12") roof I-joists (TJIs) with expanded polystyrene block insulation (EPS) inserted between the joists. The insulation is held in place with wood blocking.

The use of EPS insulation in the addition and dormer sections is acceptable from an insulation perspective however, little to no effort appears to have been made to make the underside surface of the EPS airtight at joints and connections. Further, given the position of the log framing, there would be certain areas where creating an effective airtight connection would be exceedingly difficult.

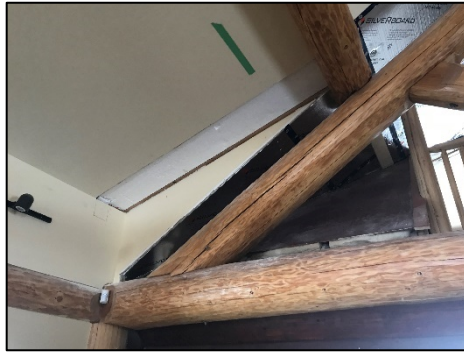
Photo #6: Framing and insulation at roof slope transition

On the west portion of the new roof, where the roof angle changes and extends over the exterior walkway, it appears 2x8 dimensional lumber joists were used instead of TJIs. The space between the dimensional lumber joists were completely filled with expanded polystyrene.

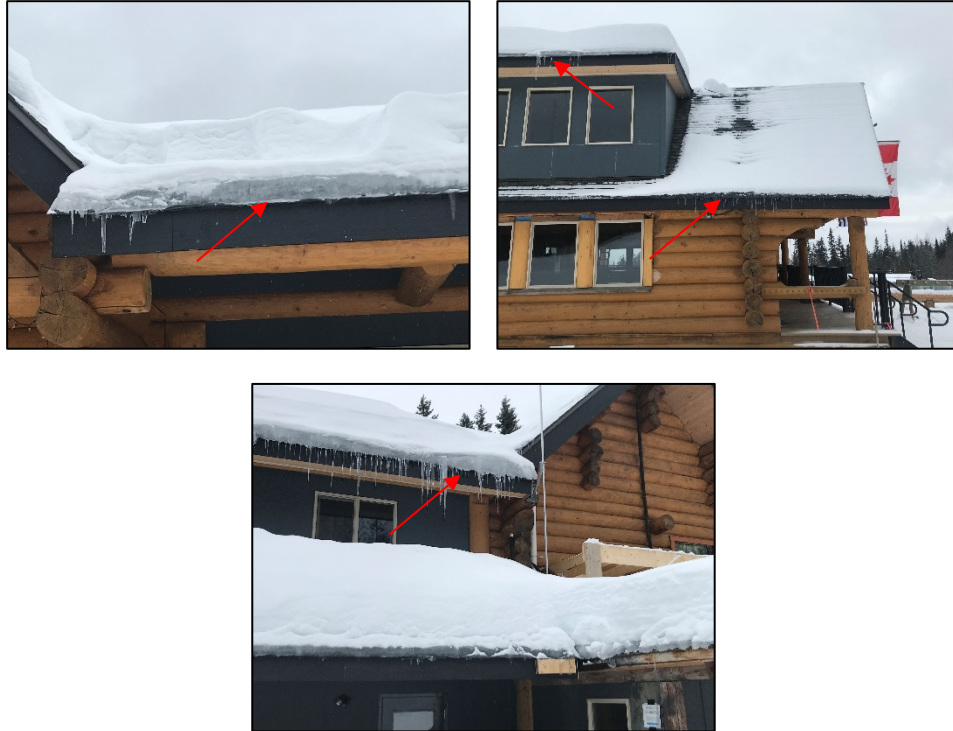
Photos #8, #9, #10: Examples of ice damming

The Ice damming observed during the site visit occurred on all elevations, except the south as no eave exists on that elevation. The amount of ice damming varied depending on location.

Ice damming can occur during cold weather when snow is present on the roof. If the roof sheathing is heated from below, the snow will melt at the shingle/snow interface. The meltwater runs down the roof to the eave. As the eave is typically outboard of the building envelope, the sheathing is at the outdoor ambient temperature. If the outdoor temperature is below 0°C, the water will freeze to the shingles. Subsequent melting events will add layers of ice to the eave, eventually forming a dam at the eave edge. The meltwater then backs up behind the dam which can then migrate under the shingles. Depending on whether underlayment has been installed below the shingles, and the type used, water penetration through the roofing system can occur.

The current level ice damming on the building is caused by non-continuous thermal insulation and ineffective control of air leakage within the roofing system.

The restoration options fall into the three categories shown below and are based on the roof restoration design. A discussion of each option is provided. All options include replacement of interior finishes.

1. Unvented roof
2. Vented Roof
3. Insulated roof

Option #1: Unvented Roof

This option requires the removal of the existing drywall, interior finishes, and insulation materials to expose the roof structure and underside of the roof deck. The underside of the roof deck would then be sprayed with 150 mm (5") of 1.8 – 2.0 PCF density, closed cell, spray-applied polyurethane foam insulation (BASF "Waltite", Icynene "MD-C-200", etc.). The insulation would be applied in maximum 50 mm lifts to ensure any cavities that form in the billowing foam are sealed. The thermal resistance of the roofing system would be approximately R-30. Please note that although spray foam is very effective in creating a tight air seal, vapour seal and thermal blanket, it is unreasonable to assume that all holes will be eliminated. The benefit of spraying to the underside of the roof deck is that, if a small hole (or "inlet") in the foam exists, as there is no ventilation space between the foam and the underside of the roof deck, there is no "outlet" to allow for air to escape. Air flow is therefore significantly restricted if not completely eliminated. Another issue may pertain to the warranty of the shingles installed on the building. A number of shingle manufacturers will not warrant their products in an unvented application as it is believed that without the ventilation space below, excessive solar heat gain would reduce the life span of the shingles. This would have to be confirmed with the manufacturer of the shingles used on the building.

Option #2: Vented Roof

This option is similar to Option #1 in that the roof structure and deck would be exposed and 1.8 – 2.0 PCF density, closed cell, spray-applied polyurethane foam insulation would be used to create the air barrier, vapour seal and thermal blanket. The difference here would be that cardboard baffles would be installed between the roof joists to create a 63 mm (2.5") ventilation gap between the underside of the roof sheathing and insulation. This would have to be installed in conjunction with ridge and soffit ventilation required by the BC Building Code for a roof of this type. The ventilation area requirement is 1/300th of the insulated roof area relatively evenly split between the soffits and ridge. Therefore, a ventilated soffit and ridge venting would need to be constructed. As the soffit is currently constructed of T&G boards covering the structural elements, this would need to be removed so a vented soffit could be constructed. Further, as it appears there is horizontal blocking between the joists at the building-to-walkway roof transition on the west elevation, this would have to be modified to allow for air flow from the ventilation space through the soffit. At the roof peaks, a continuous ridge vent would need to be constructed as it appears that the roof sheathing was not strapped. Given the heavy winter snowpack, the ridge vent would need to be a raised "dog house" style to ensure the vent is not covered over with snow. As stated above in Option #1, some minor air flow through the spray foam is possible. As this methodology provides an "outlet" through the roof vent space, air leakage may occur. The requirement of the spray foam installer achieving a tight air seal is therefore much more critical. Please note this methodology can be used with simple batt and poly in lieu of spray foam insulation however, achieving a tight air seal is exceedingly difficult and is not recommended.
